Monitoring Data Record

Project Title: R-2809B (Site 1) COE Action ID: 199601836
 Stream Name: UT to Richland Creek DWQ Numbers: 010550
 City, County and other Location Information: Wake Forest Bypass, Wake Co. (Left of Y2 Sta. 10+40 to Sta. 11+25)
 Date Construction Completed: April 2006 Monitoring Quarter: (3) of 4
 Ecoregion: _____ 8 digit HUC unit: 03020201
 USGS Quad Name and Coordinates: _____

Wake Forest Bypass

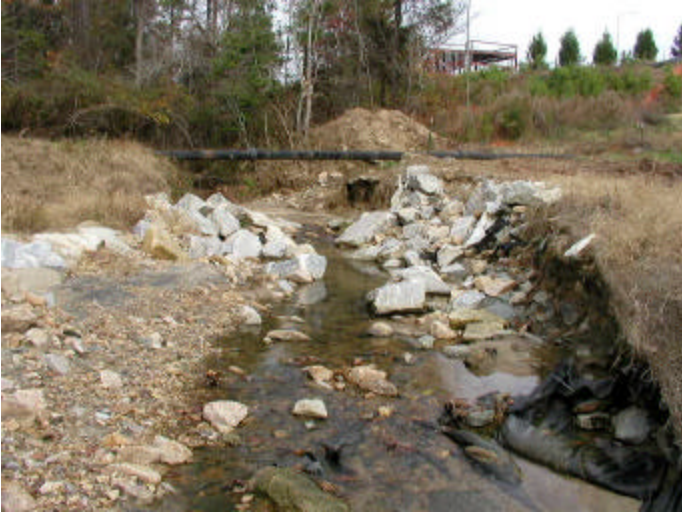
Photo 1 (Upstream)

Date Inspected	Station Number	Station Number	Station Number	Station Number	Station Number
Structure Type	Photo 1	Photo 3	Photo 5	Photo 6	
Is water piping through or around structure?			Water piping around left arm of cross vane		
Head cut or down cut present?					
Bank or scour erosion present?	Erosion on left bank	Erosion on right bank	Erosion on right bank	Erosion on left bank	
Other problems noted?		Erosion behind right arm of cross vane	Erosion behind right and left arms of cross vane	Erosion behind left arm of cross vane
